Wirkungsvolle Maßnahmen zur Sanierung sozialer Wohnungsbauten - Retrofit of social houses

Energy Solutions
for cities and communities
November 7th 2008
Eurogress Aachen

HOLISTIC - Mödling

Social housing

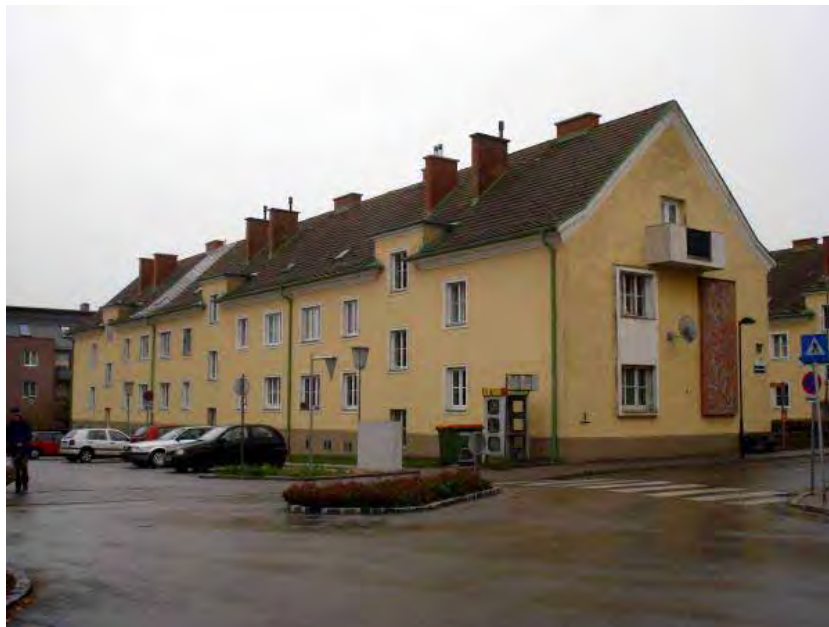
Two performed actions regarding social houses are presented in detail ...

**T - Mobile thermal imager for conducting qualitative and quantitative analysis.
R - Retrofitting the building environment.**

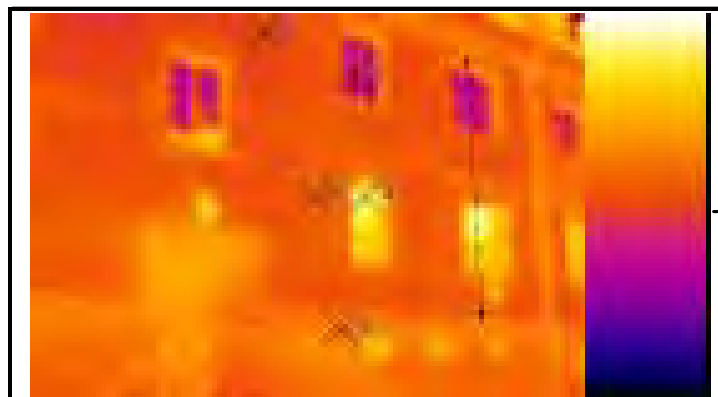
14,6°C **The identified weakest points of the building are ...**

- Old windows
- Bad wall insulations
- Bad insulated cellar walls

Temp.	Comment
5.3 °C	New Glazing
13.6 °C	Old window
8.5 °C	Outside wall
9.5 °C	Plinth brickwork
7.8 °C	Outside wall

7,7°C **Resulting into recommended actions...**

- New windows
- Better wall insulations of upper floors
- Better insulations of the cellar wall

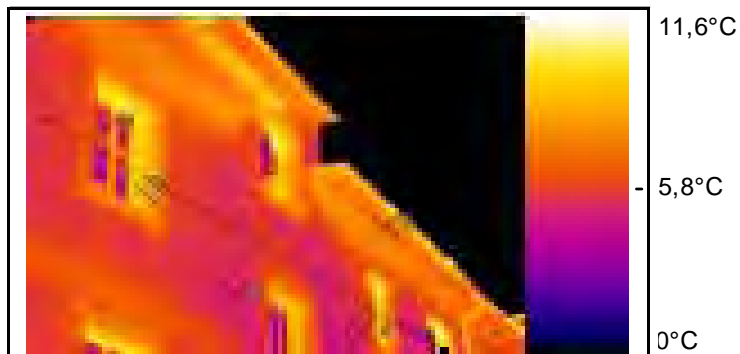
Temp.	Comment
9,2 °C	Old window sides
5,3 °C	Good new glazing
5,1 °C	Old Wall without insulation
6,9 °C	Roof overhang

The identified weakest points of the building are ...

- Old windows
- No wall insulation
- Bad dormer walls
- Heat bridges at the roof overhang

Resulting into recommended actions ...

- New windows
- Better wall insulations of upper floors
- Insulations of the dormer walls
- Insulations of the roof overhang

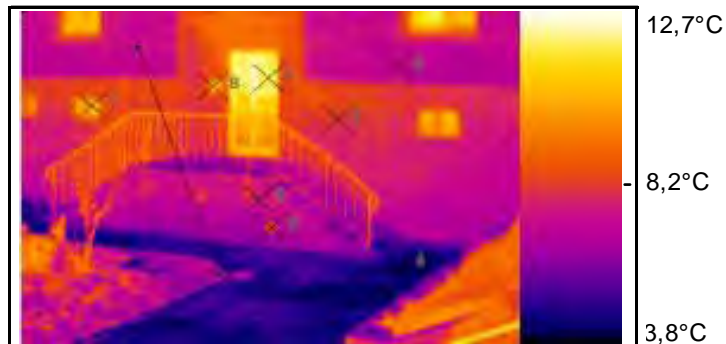
Temp.	Comment
11,9 °C	Door with old glazing
7,1 °C	Different qualities of wall insulations
7,8 °C	Bad insulated cellar wall
8,2 °C	Ventilation pipes
10,5 °C	High Voltage Intercom

The identified weakest points of the building are ...

- Old windows
- Different qualities of wall insulations
- Bad insulated main door

Resulting into recommended actions...

- New windows
- Better wall insulations of upper floors
- Better insulations of the cellar wall
- New main door

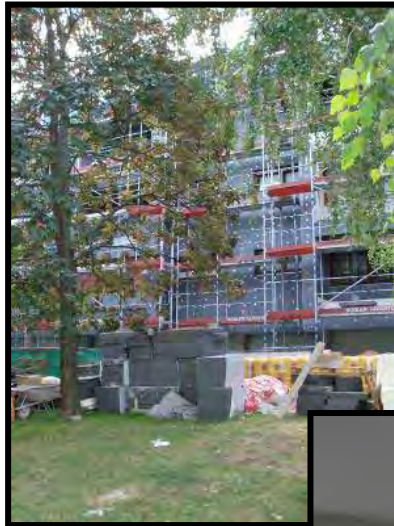
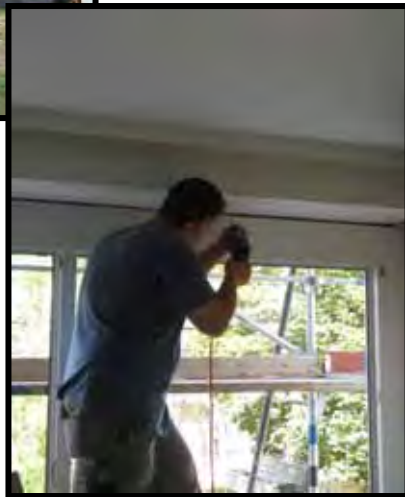
The performed measures are ...

- Minimization of heat losses, insulated envelope with U-values between 0.16 and 0.27 W/m²K
- Installation of new windows with a total k-value between 1.26 W/m²*K and 1.53 W/m²*K
- Insulation of the roof 0.14 W/m²*K, of the cellar roof 0.21 W/m²*K, of in between roofs 1.36 W/m²*K

Heat energy demand per m² of total used conditioned floor area:

- 32.06 kWh/m²*a

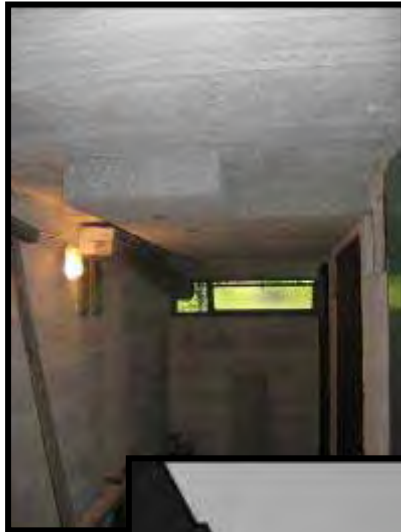
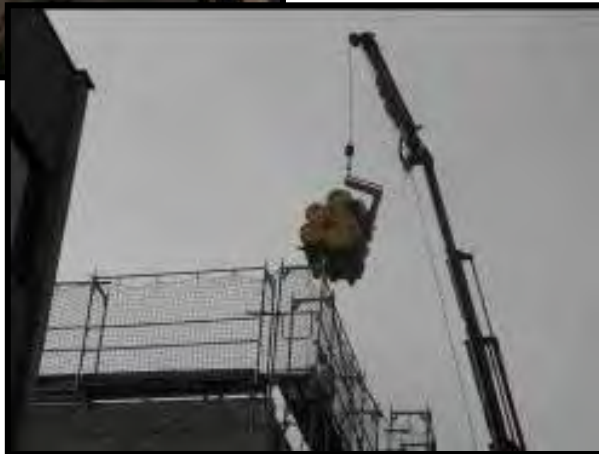
Various insulation measures are implemented such as ...

- Exterior wall with 10 cm EPS (Expanded Polystyrene) on washed-out concretes / polystyrene / ferroconcretes or Exterior wall with 10 cm EPS on OSB (Oriented Strand Board) / mineral wool / plaster
- Cellar/garage roofs with 15cm Protteolith (concrete enveloped EPS) on ferroconcretes
- Roofmates with 20cm XPS (Extruded Polystyrene) on bitumen binder

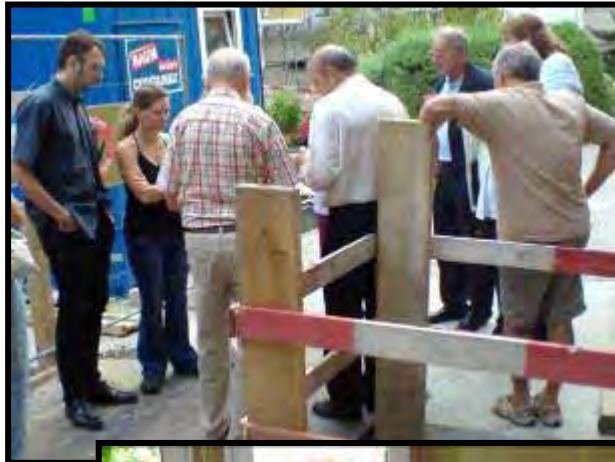
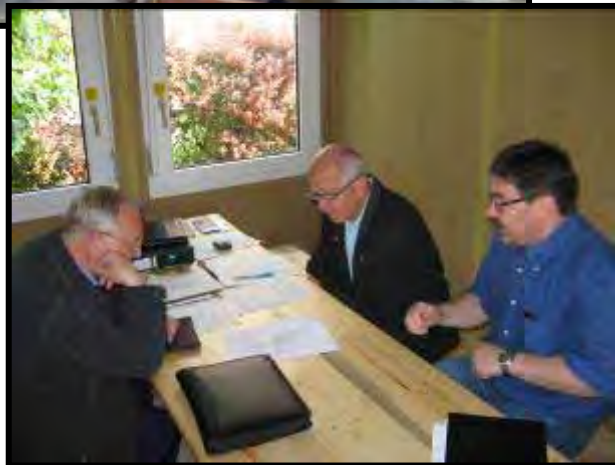
Step-by step realisation of the energy efficiency measures started in May 2008 and include particularities regarding integrating building users ...

- **Communication flow / quality assurance debates on weekly meetings.**
- **Its costs and schedule are advertised and discussed with 2 representatives.**
- **Distribution and intermediation among all involved parties.**
- **Few building users complain particular delays, most of them seems satisfied as requested structural damages in the construction are repaired.**

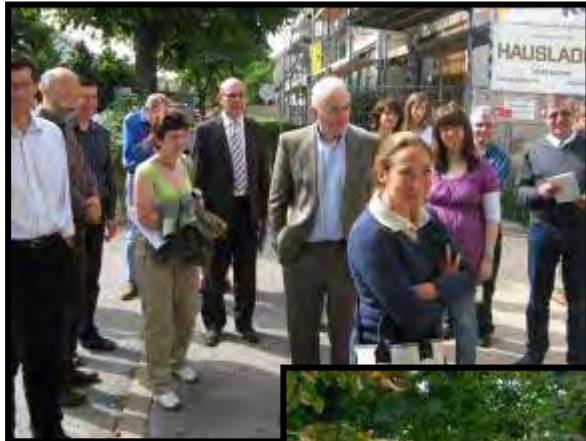
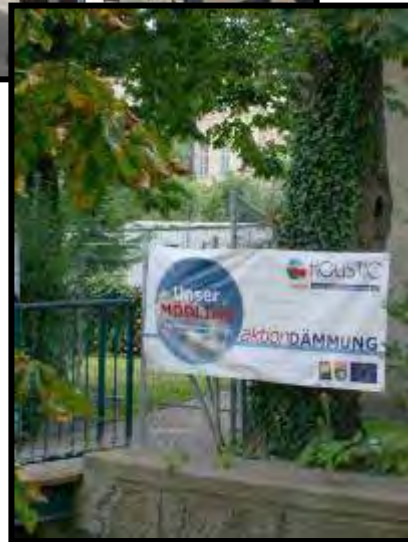
Added value beyond minimising energy costs ...

- Save heating energy and green house gas emissions
- Improved indoor climate (better air quality, sound insulation, heat insulation)
- Increased social well being and health
- Reduced CO₂-concentration inside the building (especially in bed room)
- Enhanced property value
- Increased urban living standard / city image
